**Retrieval of Damaged Components  
from Experimental Fast Reactor Joyo  
Reactor Vessel**

**June . 8<sup>th</sup> , 2010**

**Japan Atomic Energy Agency (JAEA)**

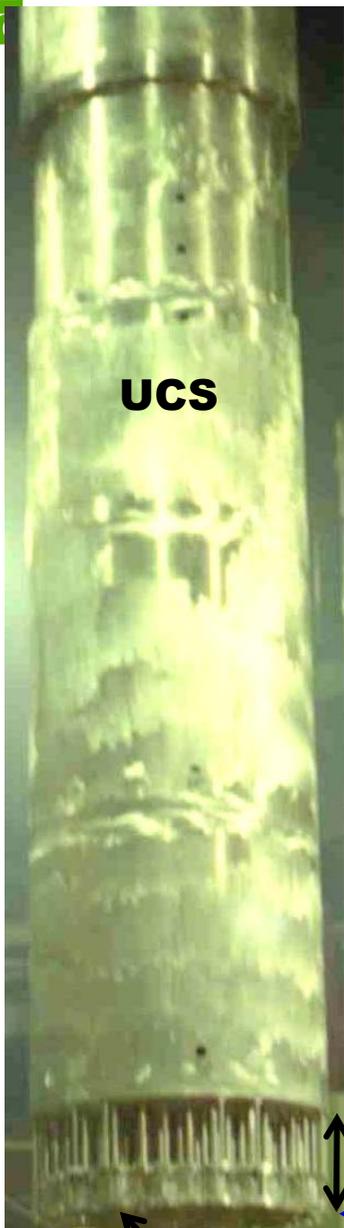
# Dose rate on UCS surface

## - Evaluation results -

**Sodium flow regulating grid**

450mm

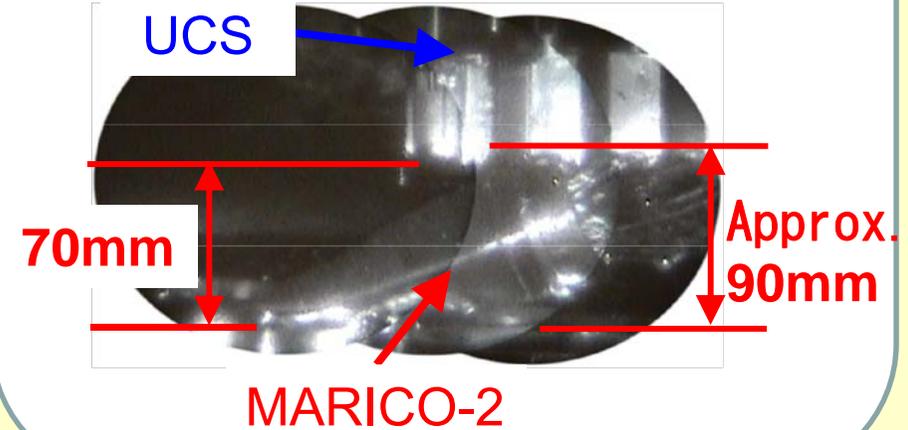
# Retrieval procedure of bent MARICO-2

## Access route

## Geometric condition

UCS can not be positioned right above the bent MARICO-2 to avoid a contact with it.

The retrieval device employs  
***“offset configuration”***

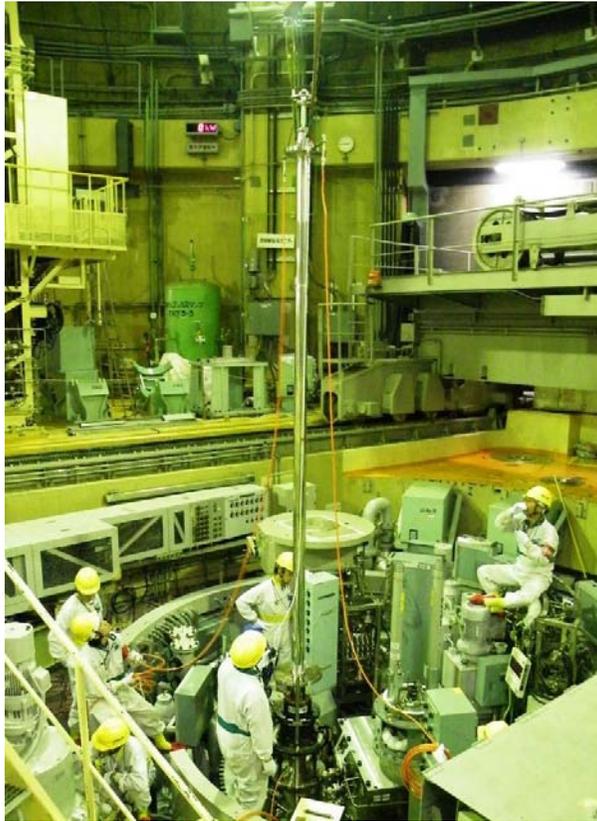
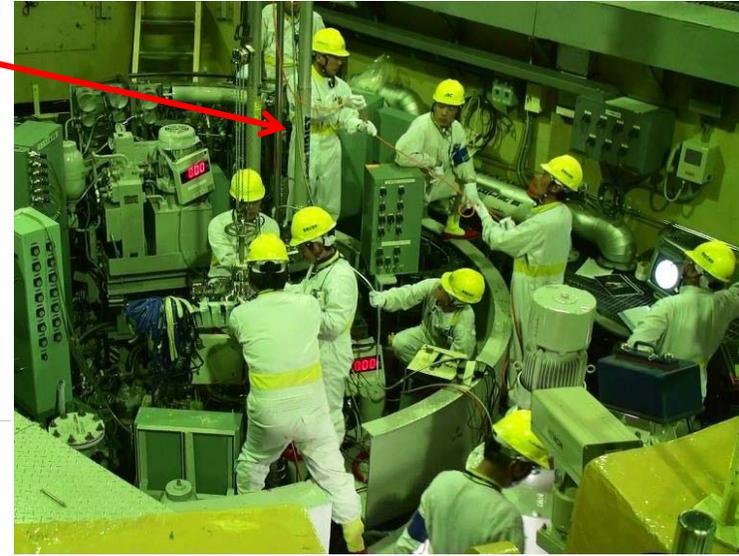
# Lifting-up test

**Lifting-up device**  
( In-vessel  
inspection hole (A) )

**Insertion of device**

**Fiberscope**  
(Fuel handling hole)

**Adjusting angle of fingers**
